The Integrity of Cover Systems – An Update

By G W Wilson, Department of Mining Engineering, University of British Columbia;
D J Williams, Department of Civil Engineering, The University of Queensland; and
E M Rykaart, SRK Consulting, Canada

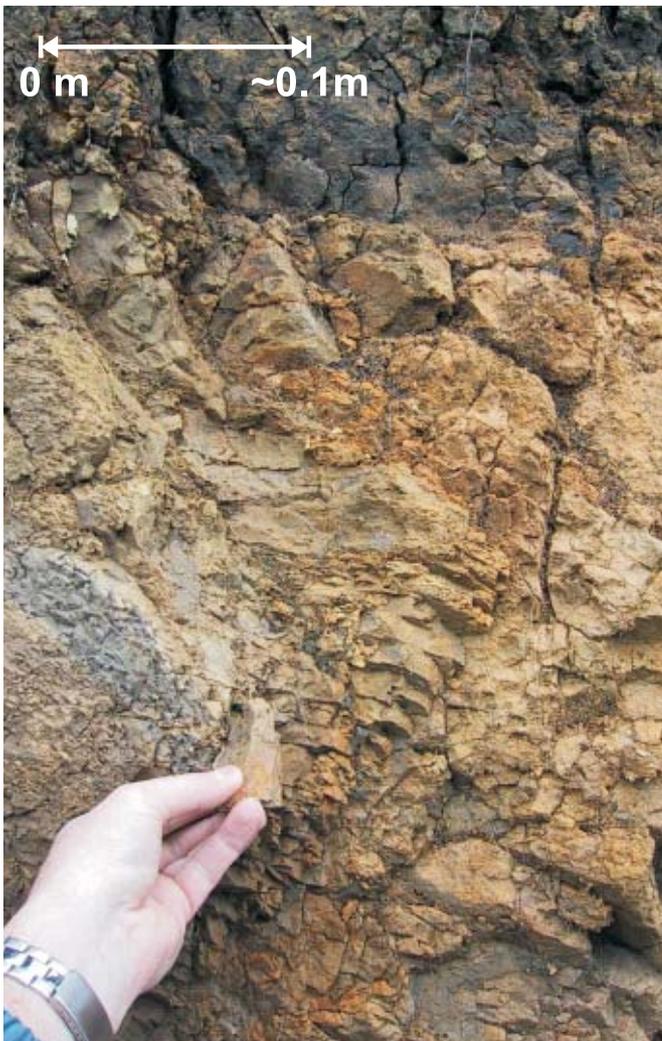
Figure 5: Highly plastic clay with nuggety fractured structure.

drying, as well as freezing and thawing produce environmental fatigue in the barrier layer. Highly plastic clays have the highest sensitivity to these stresses and develop a nuggety, fractured structure in the active layer, as shown in Figure 5, resulting in values of *in situ* hydraulic conductivity three and sometimes four orders of magnitude greater than the value measured in a compacted state in the laboratory.

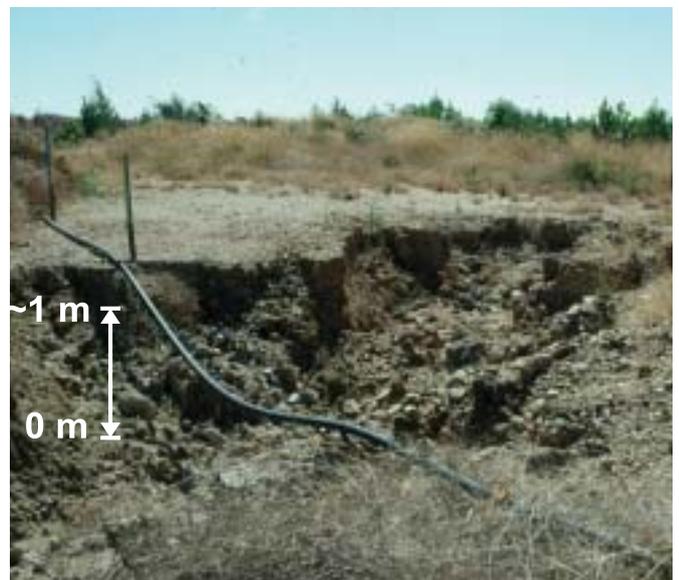
Figure 7: Erosional gully in fine-grained soil due to high intensity storm.

Erosion is a failure mechanism that may destroy the integrity of any cover. Figures 6 and 7 illustrate erosional damage of the barrier cover at the Equity Silver Mine, in British

Columbia, Canada and the store/release cover at Kidston gold mine respectively. A storm event at Equity Silver with a return of approximately 200 years caused a slump to occur in an over-steepened region of the cover (Figure 6). Fortunately, this minor failure occurred in an isolated over-steepened section of the cover, and was readily repaired. The erosional gully shown at the Kidston site occurred in a non-vegetated section of a test cover during a typical summer storm. While minor failures were easily remedied at the Equity and Kidston sites, they illustrate the type of damage that may occur in full-scale cover systems that are not properly designed. In general, the threat of severe erosion is considered of greatest risk to store/release cover systems on side slopes or where run-off may converge. This may be attributed to three key factors. Firstly, store/release covers are placed as loose, low-density materials. Secondly, the vegetative canopy is often stressed due to lack of rainfall and thus the surface of the cover becomes exposed and susceptible to erosion. Finally, the nature of semi-arid climate systems generally produces high intensity storms.
